Lawrence Livermore National Laboratory

UCRL-AR-126020-10

LLNL Ground Water Project 2010 Annual Report

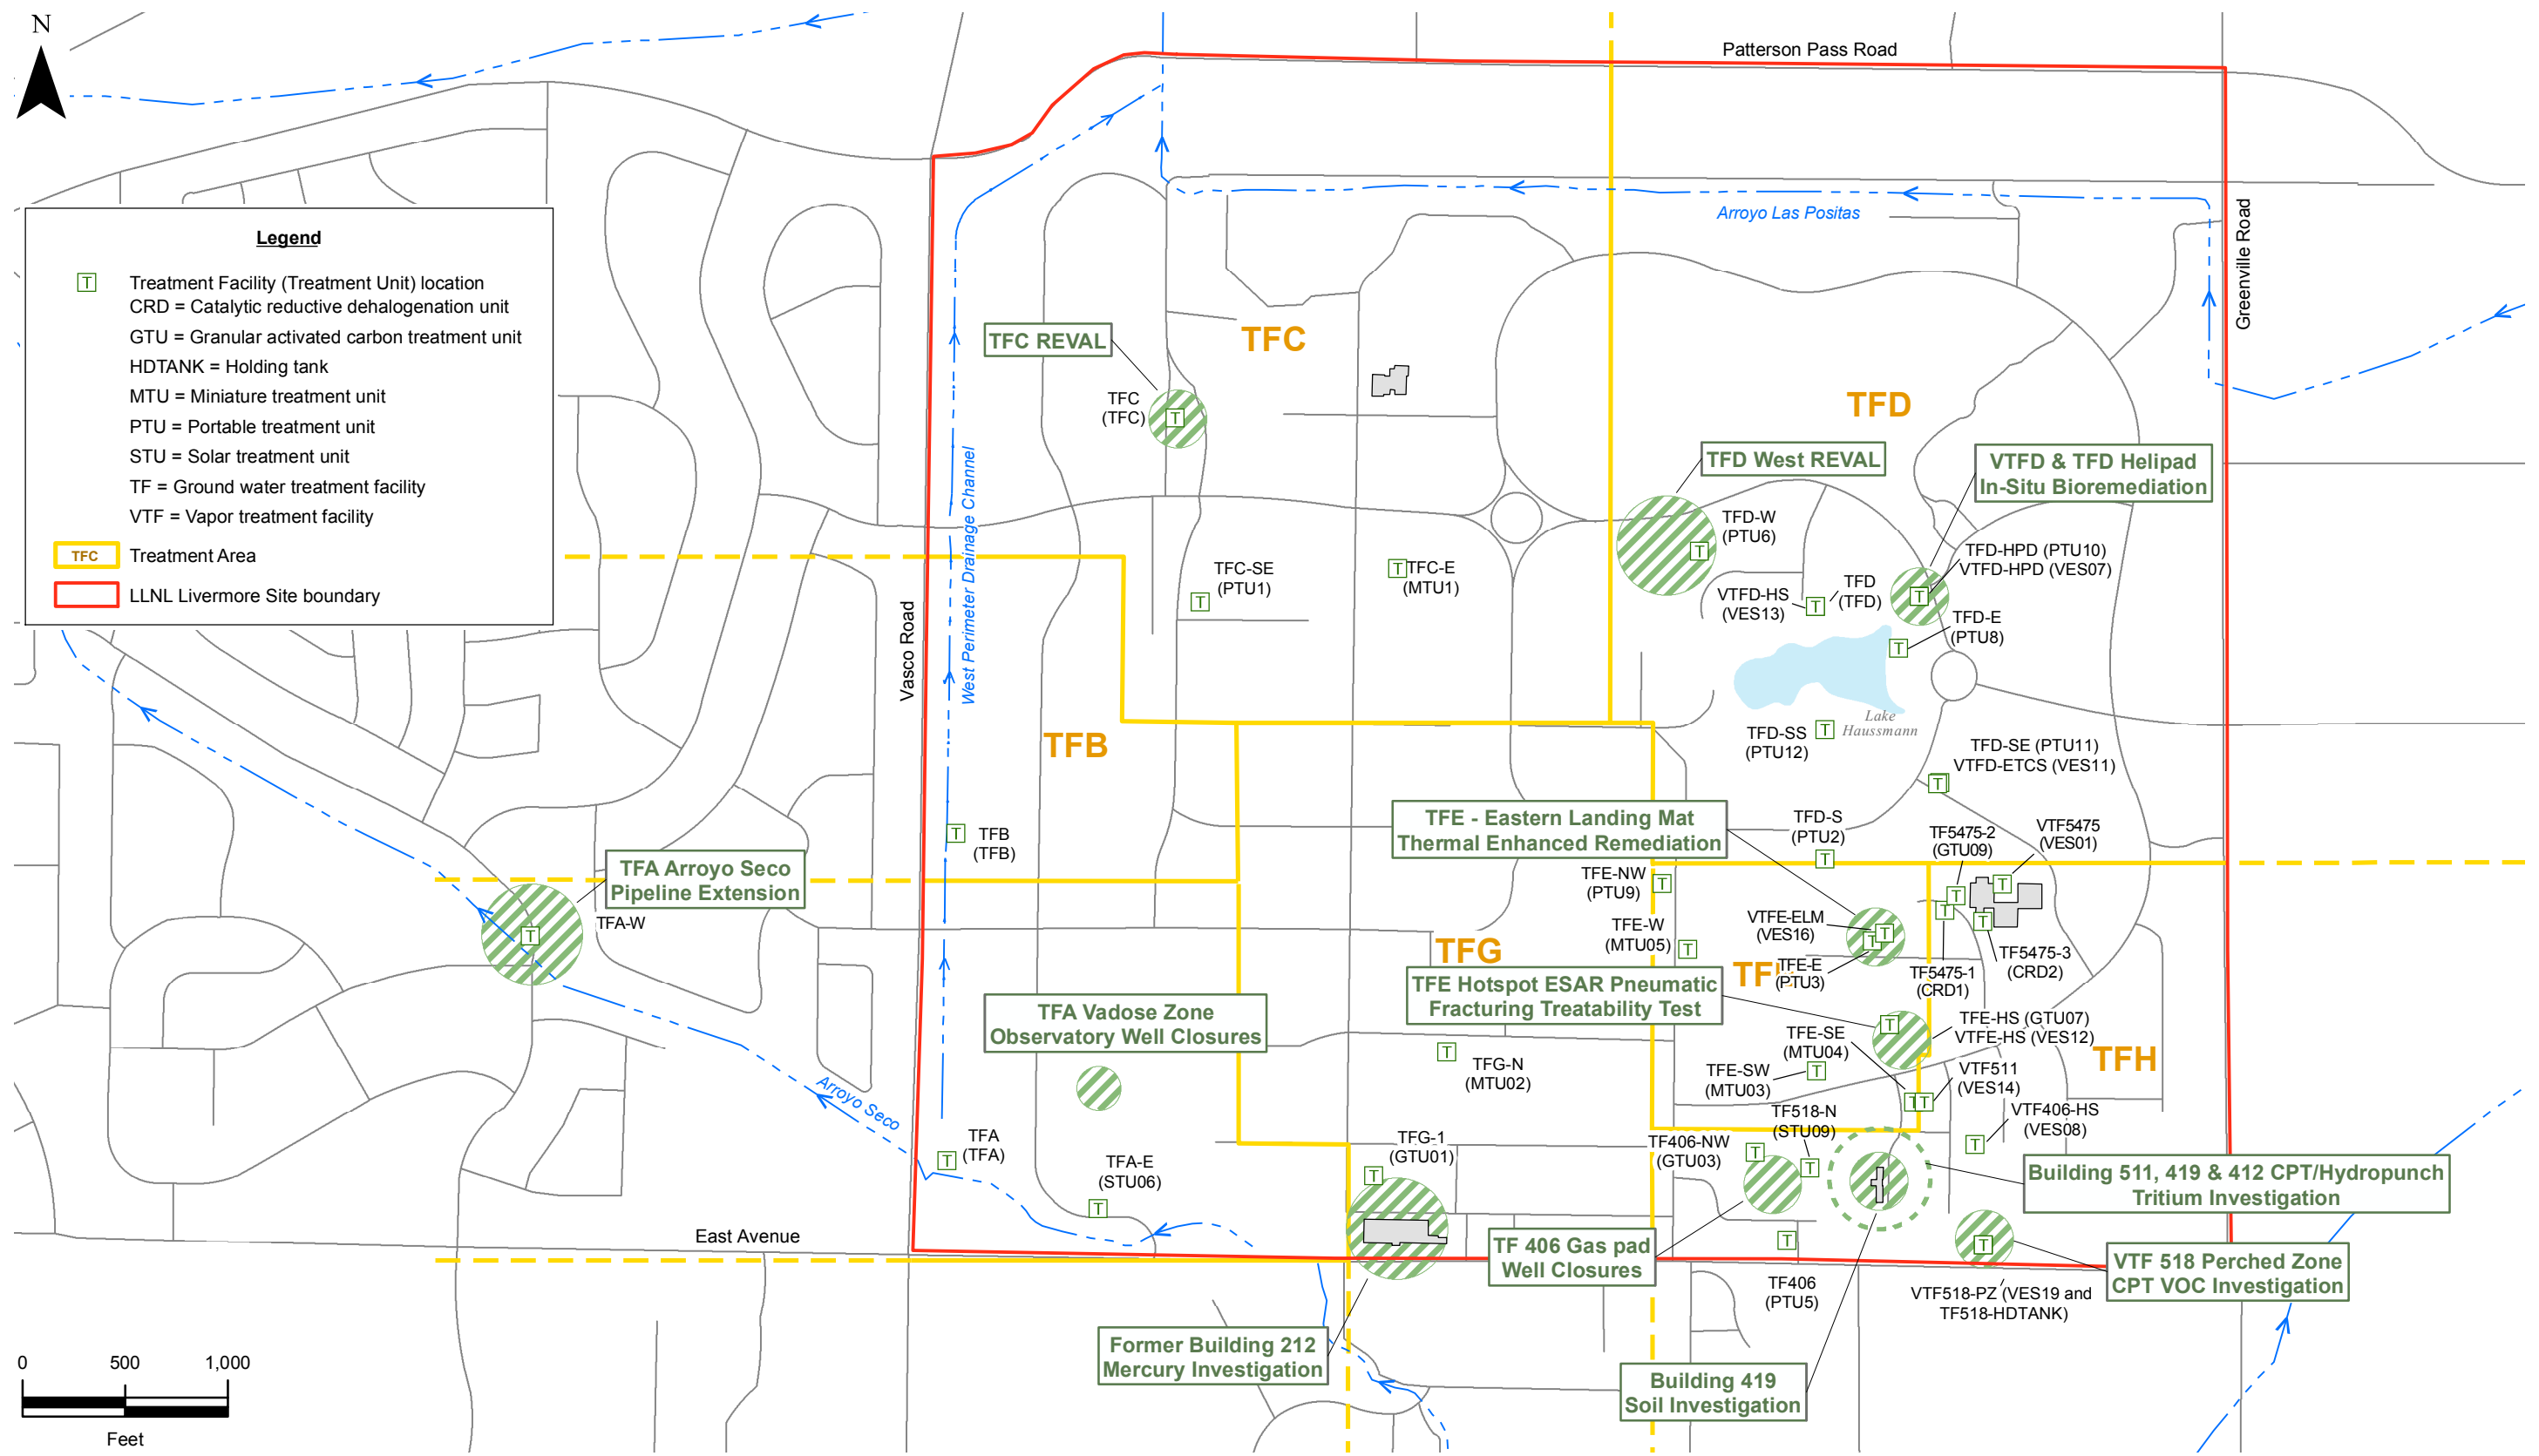
Figure 1b. Livermore Site location map of significant projects conducted in 2010.

- Initiating enhanced source area remediation (ESAR) treatability tests at TFE Hotspot (pneumatic fracturing) and TFD Helipad (bioremediation), and preparing for a third treatability test at TFE Eastern Landing Mat (enhanced thermal remediation) (Figure 1b).

Two direct-push cone penetration-testing (CPT) surveys were conducted during 2010 (Figure 1b). The strategy employed in these surveys was to use CPT data to identify zones where samples of water or vapor could be collected, and then sample these zones with direct-push technology. In July and August, borings B-2650 through B-2669 were advanced in the VTF518 Perched Zone area to profile the area lithology and acquire soil vapor samples to help better delineate the VOC source in the area. Attempts were also made to sample perched water, but none was observed in sufficient quantity to sample. In September and October, a second direct-push survey was conducted in the vicinity of former Buildings 514 and 412, and existing Buildings 511, 411, and 419. The objective of the survey was to help identify and delineate the source of the tritium in ground water that has recently been detected in TF518 North and TFE Southwest extraction well influent, and to better delineate the VOC plumes in ground water in this area. The borings associated with this survey were named B-2670 through 2688.

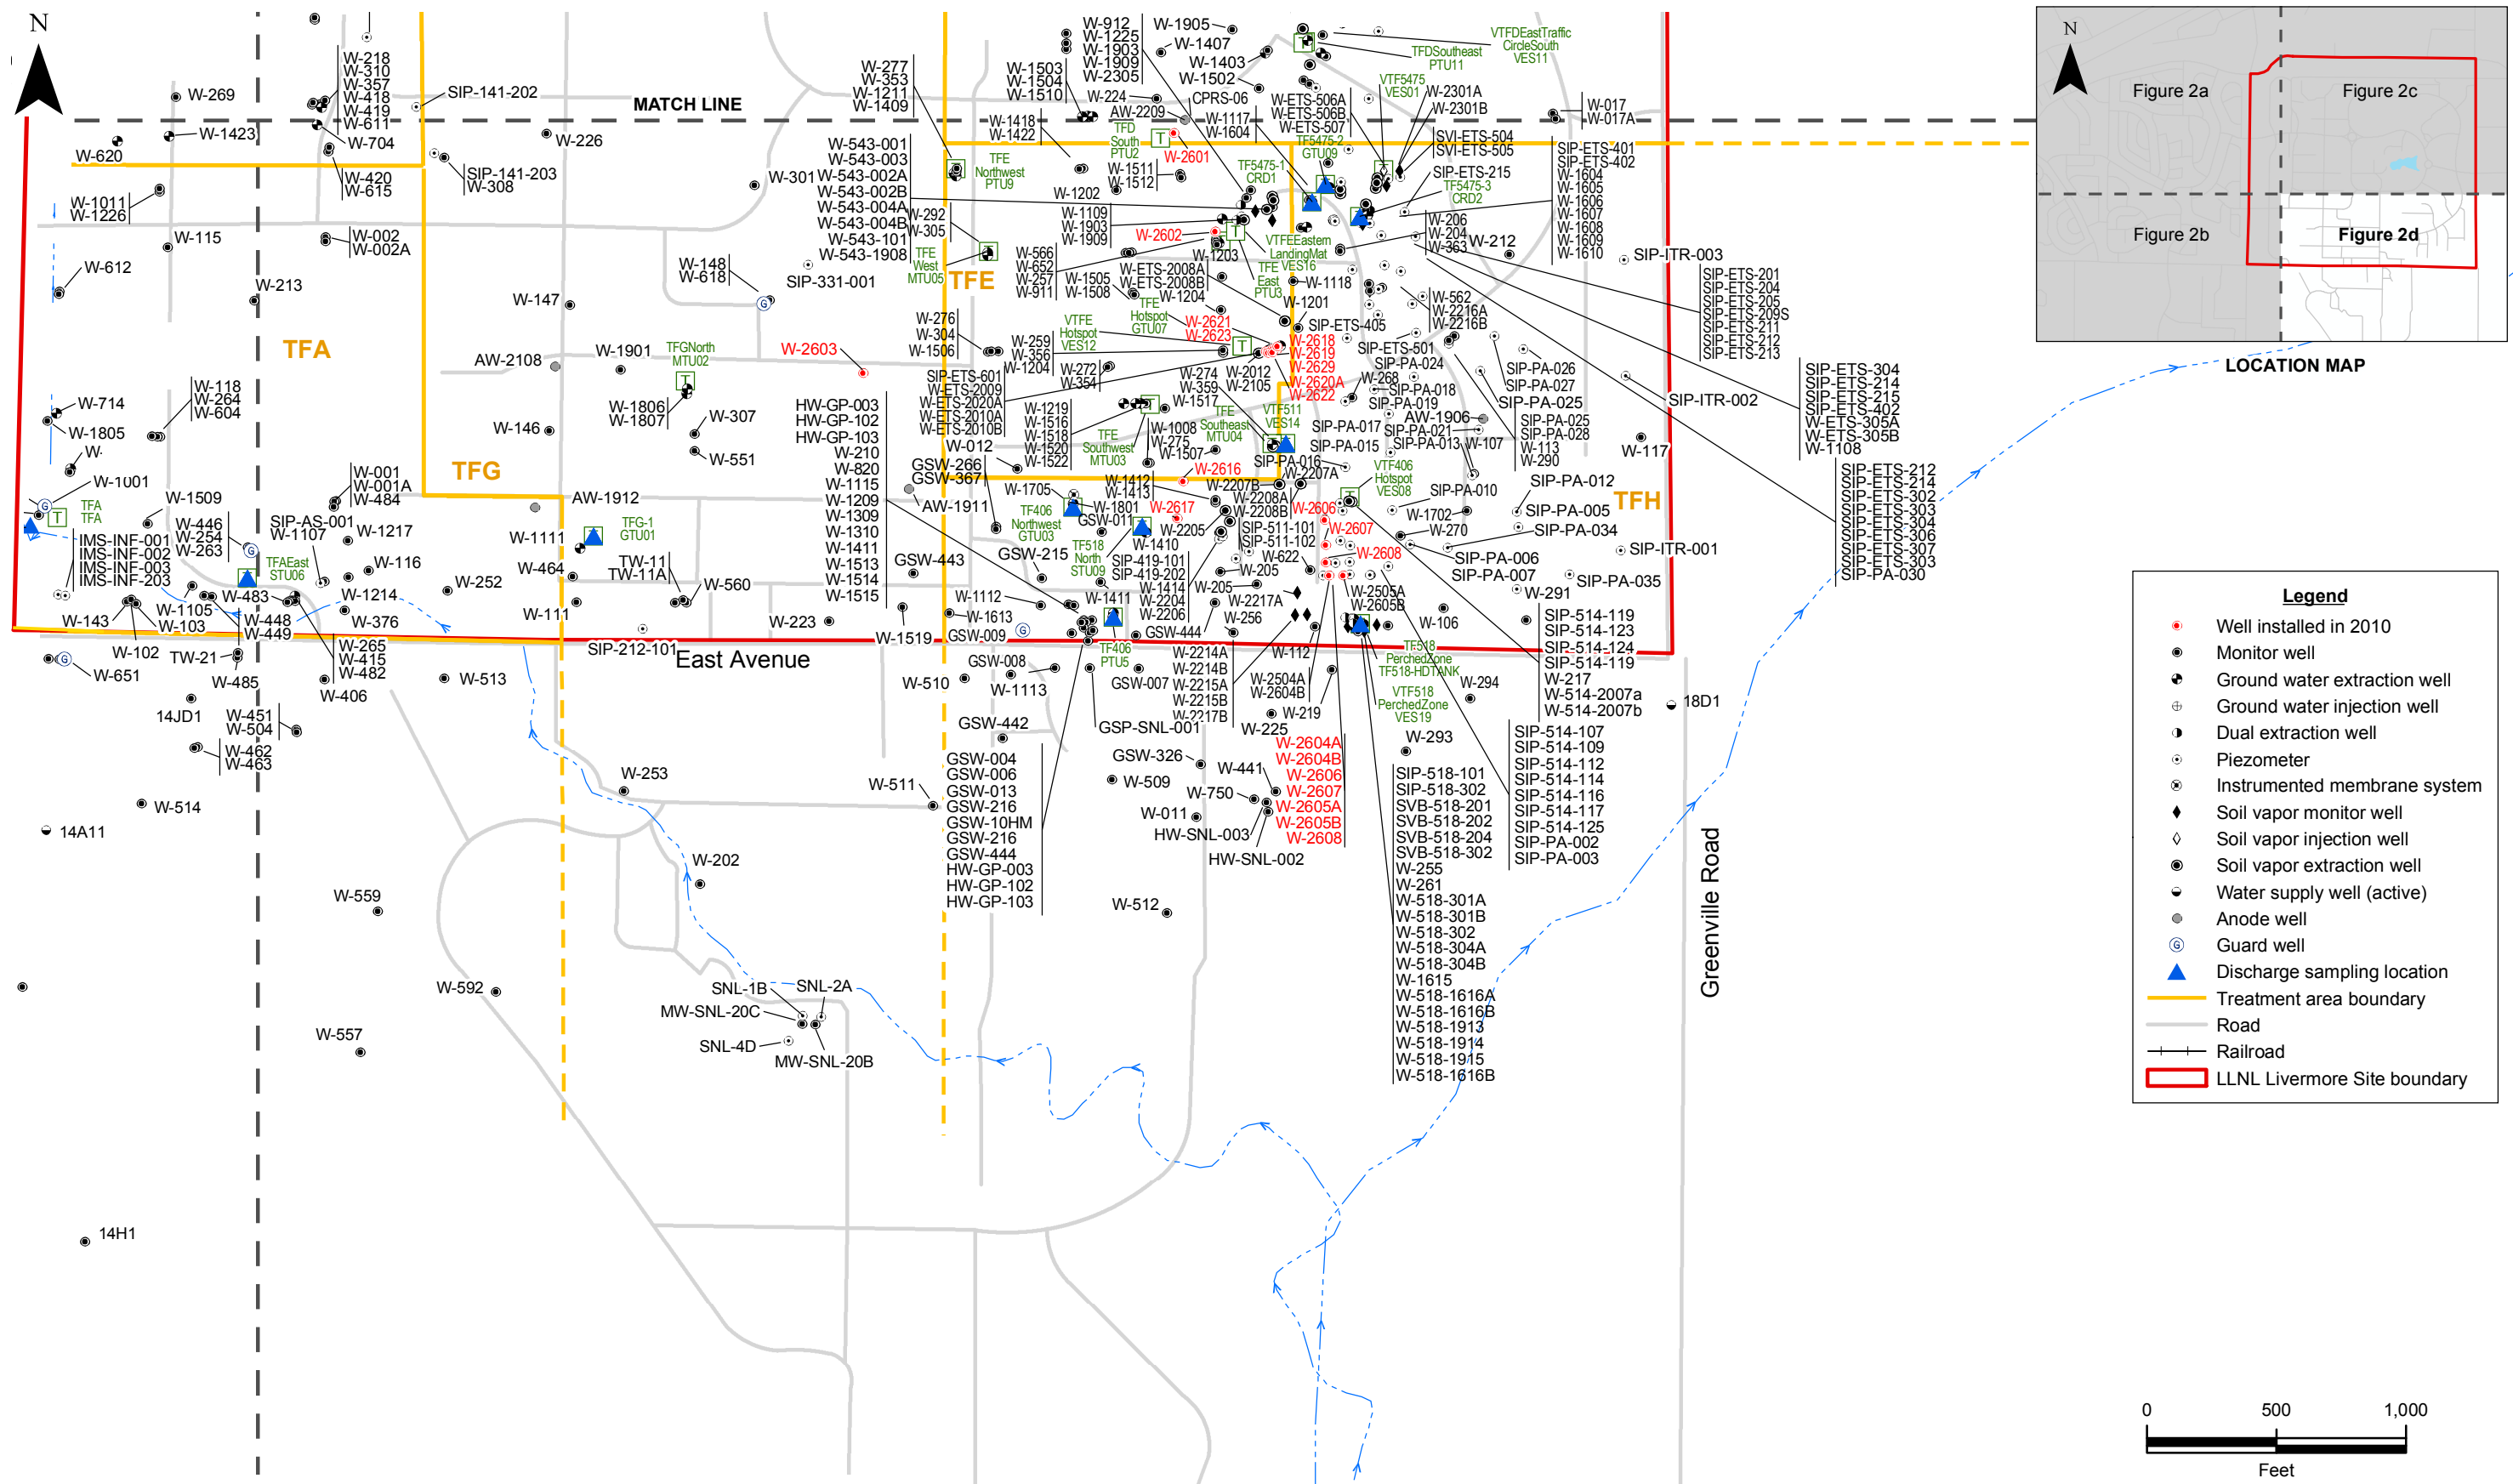
Figure 2d. Locations of Livermore Site wells and treatment facilities, December 2010.

Prior to the pneumatic fracturing, pneumatic testing was conducted in soil vapor extraction wells W-ETS-2008A, W-ETS-2008B, W-ETS-2009, W-ETS-2010A, W-ETS-2010B, and dual extraction well W-2105 (Figure 2d). Hydraulic testing was also conducted in dual extraction well W-2105, extraction well W-2012, and piezometer SIP-ETS-601, before fracturing. These tests will be repeated in 2011 and a comparison of the pre- and post-fracturing data will help quantify any changes in local hydraulic conductivity and storativity, in the hydraulic interconnectivity between wells, and in the improvement of the sediment permeability. W-2012 was damaged during pneumatic fracturing; this well will be sealed and replaced in 2011.

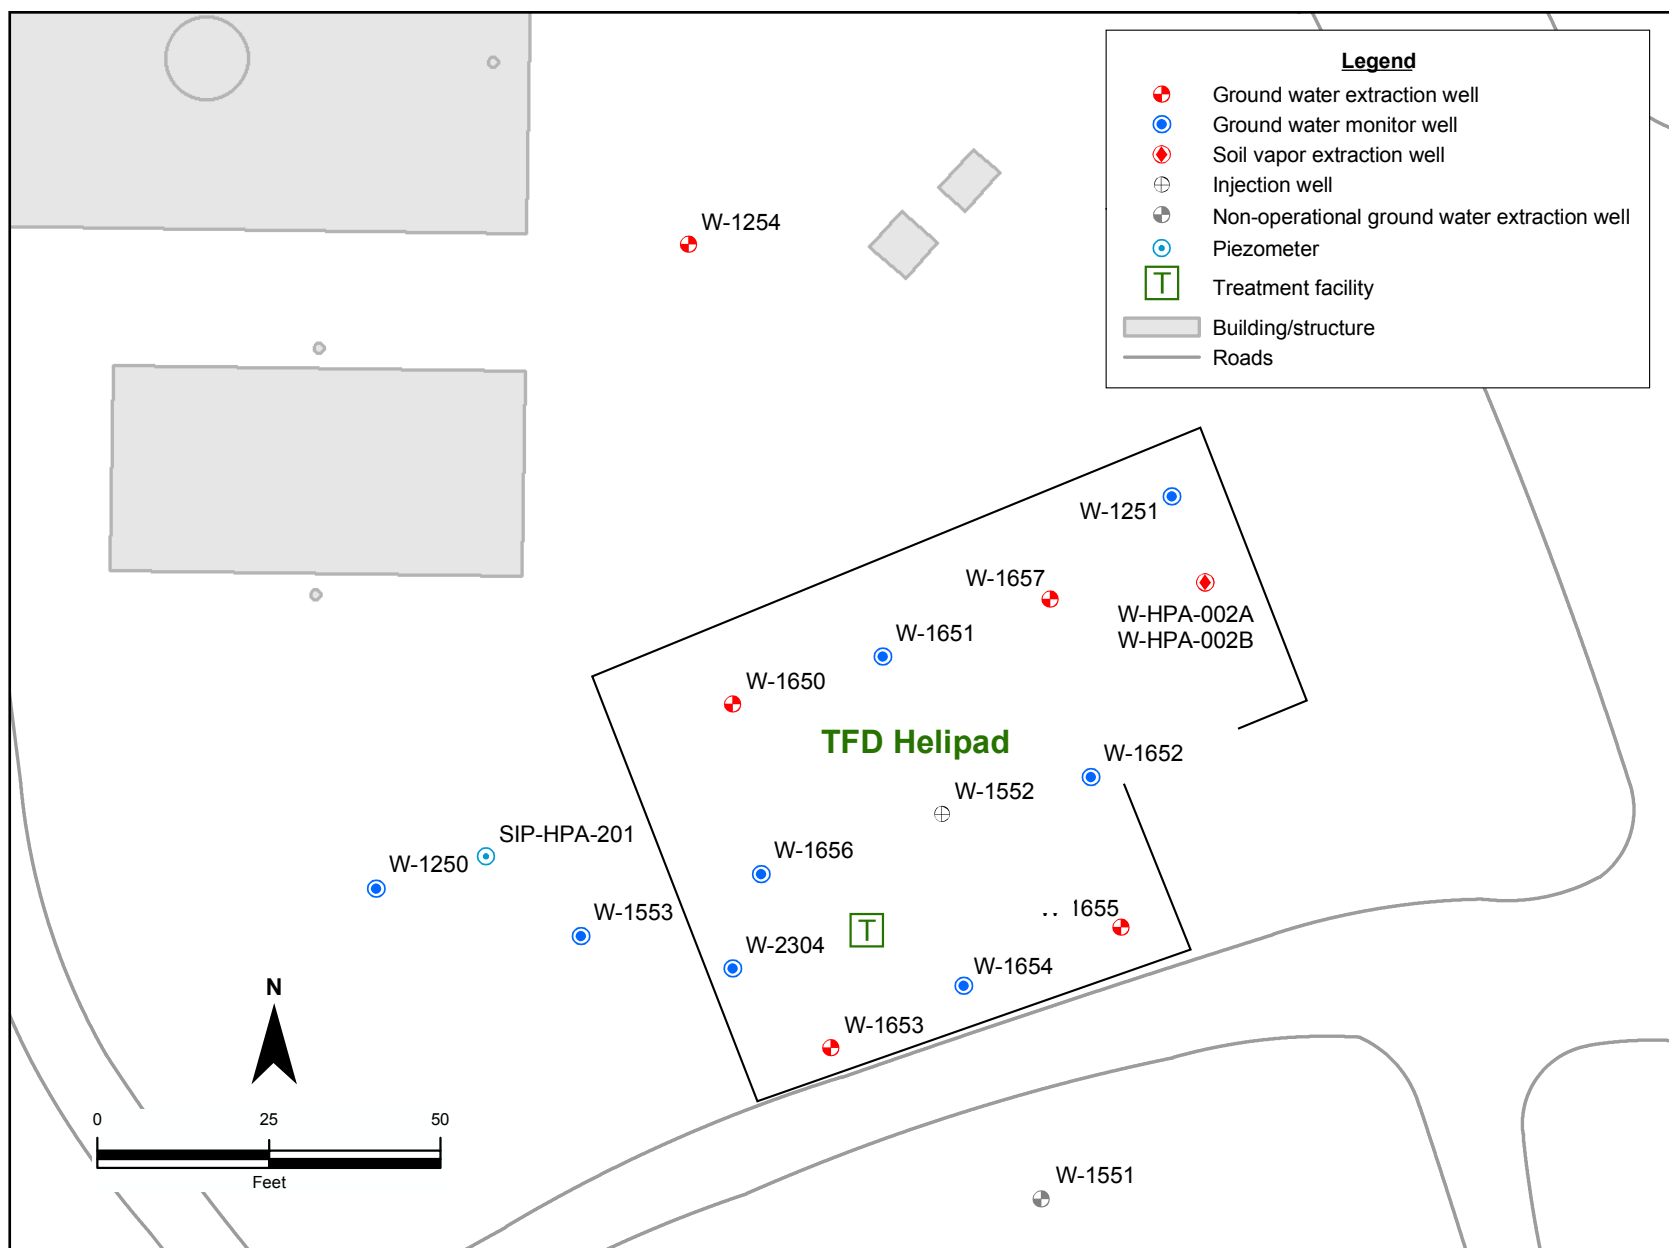
ERD_LSR_11_0028

Figure 2e. Locations of TFD Helipad wells and facilities.

The ISB01 facility includes four extraction wells, W-1650, W-1653, W-1655, and W-1657, and one central injection well, W-1552 (Figures 1 and 2e). The extraction and injection well pattern is designed to create a circulation cell that is vertically contained within the HSU-3A/3B hydrostratigraphic unit (HSU) and horizontally contained within the TFD Helipad Source Area. Currently, ground water is being recirculated to establish hydraulic control in the subsurface. In 2011, a dye-tracer injection test will be conducted to define the extent of the area under remediation and to determine travel times between wells. Following this test, a carbon source (sodium lactate) will be injected to stimulate subsurface bioactivity. This is expected to create anaerobic subsurface conditions favorable to the introduction of a dechlorinating microorganism (KB-1). Once the dechlorinating microorganism is introduced, the system will be continually operated until VOC levels are reduced below regulatory limits.

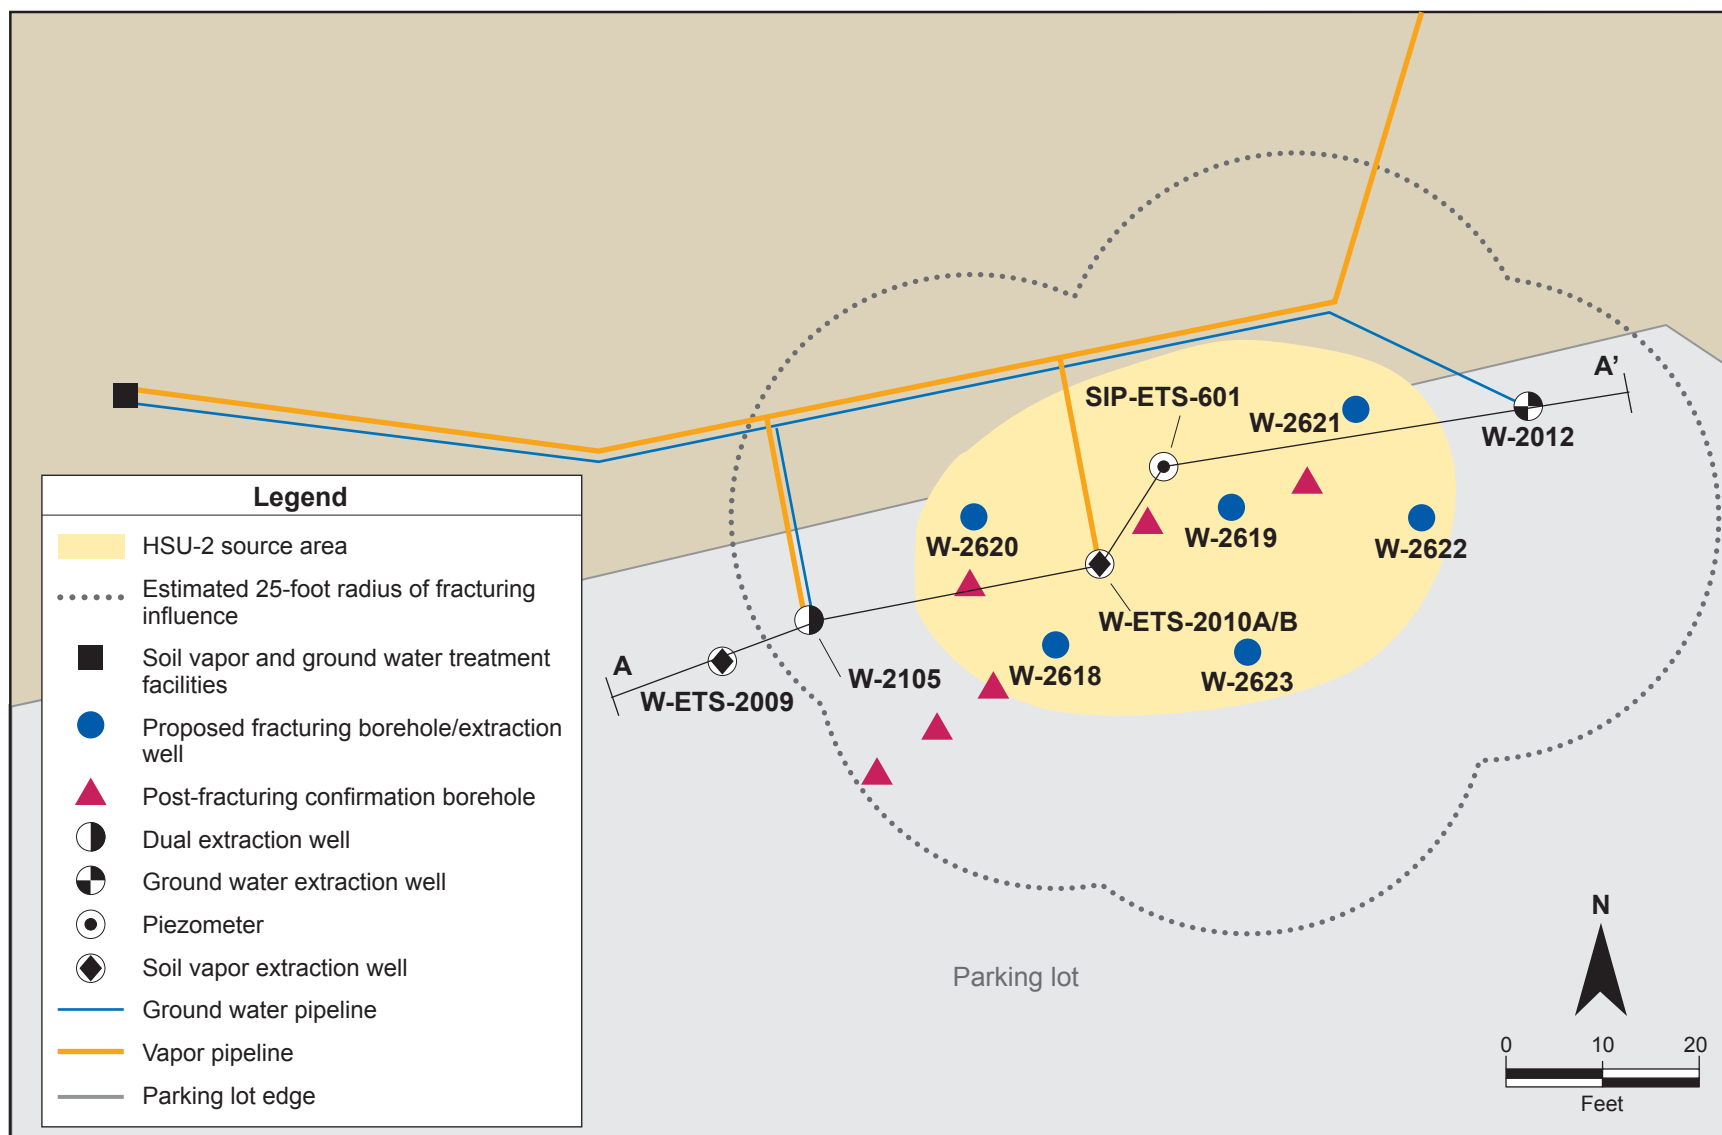
Figure 2f. Locations of the wells in the TFE Hotspot Pneumatic Fracturing Treatability Study Area.

In October 2010, an ESAR treatability test was conducted at the TFE-Hotspot source area (Figures 1b and 2f) to assess whether pneumatic fracturing could enhance the permeability of low-permeability, silt- and clay-rich source area sediments. Pneumatic fracturing involves the application of high-pressure gas to the subsurface to initiate fracturing in targeted areas. Doing so would accelerate transfer of contaminant mass from the source area by improving the yield of soil vapor and ground water extraction. The treatability test included pneumatically fracturing the vadose and saturated zone in six boreholes at 3-foot intervals between 75 and 105 feet below ground surface (ft bgs) and emplacing an inert sand proppant in the propagated fractures. In addition, two tracer dyes were injected into one fracture borehole in conjunction with the proppant to visually enhance fracture documentation in the field.

boreholes were enlarged to a minimum 9-inch diameter to install 4-inch ID PVC dual extraction wells. All six wells identified as W-2618, W-2619, W-2620A, W-2621, W-2622, and W-2623 (Figure 2f) were screened across the fracture interval (75 to 105 ft bgs).

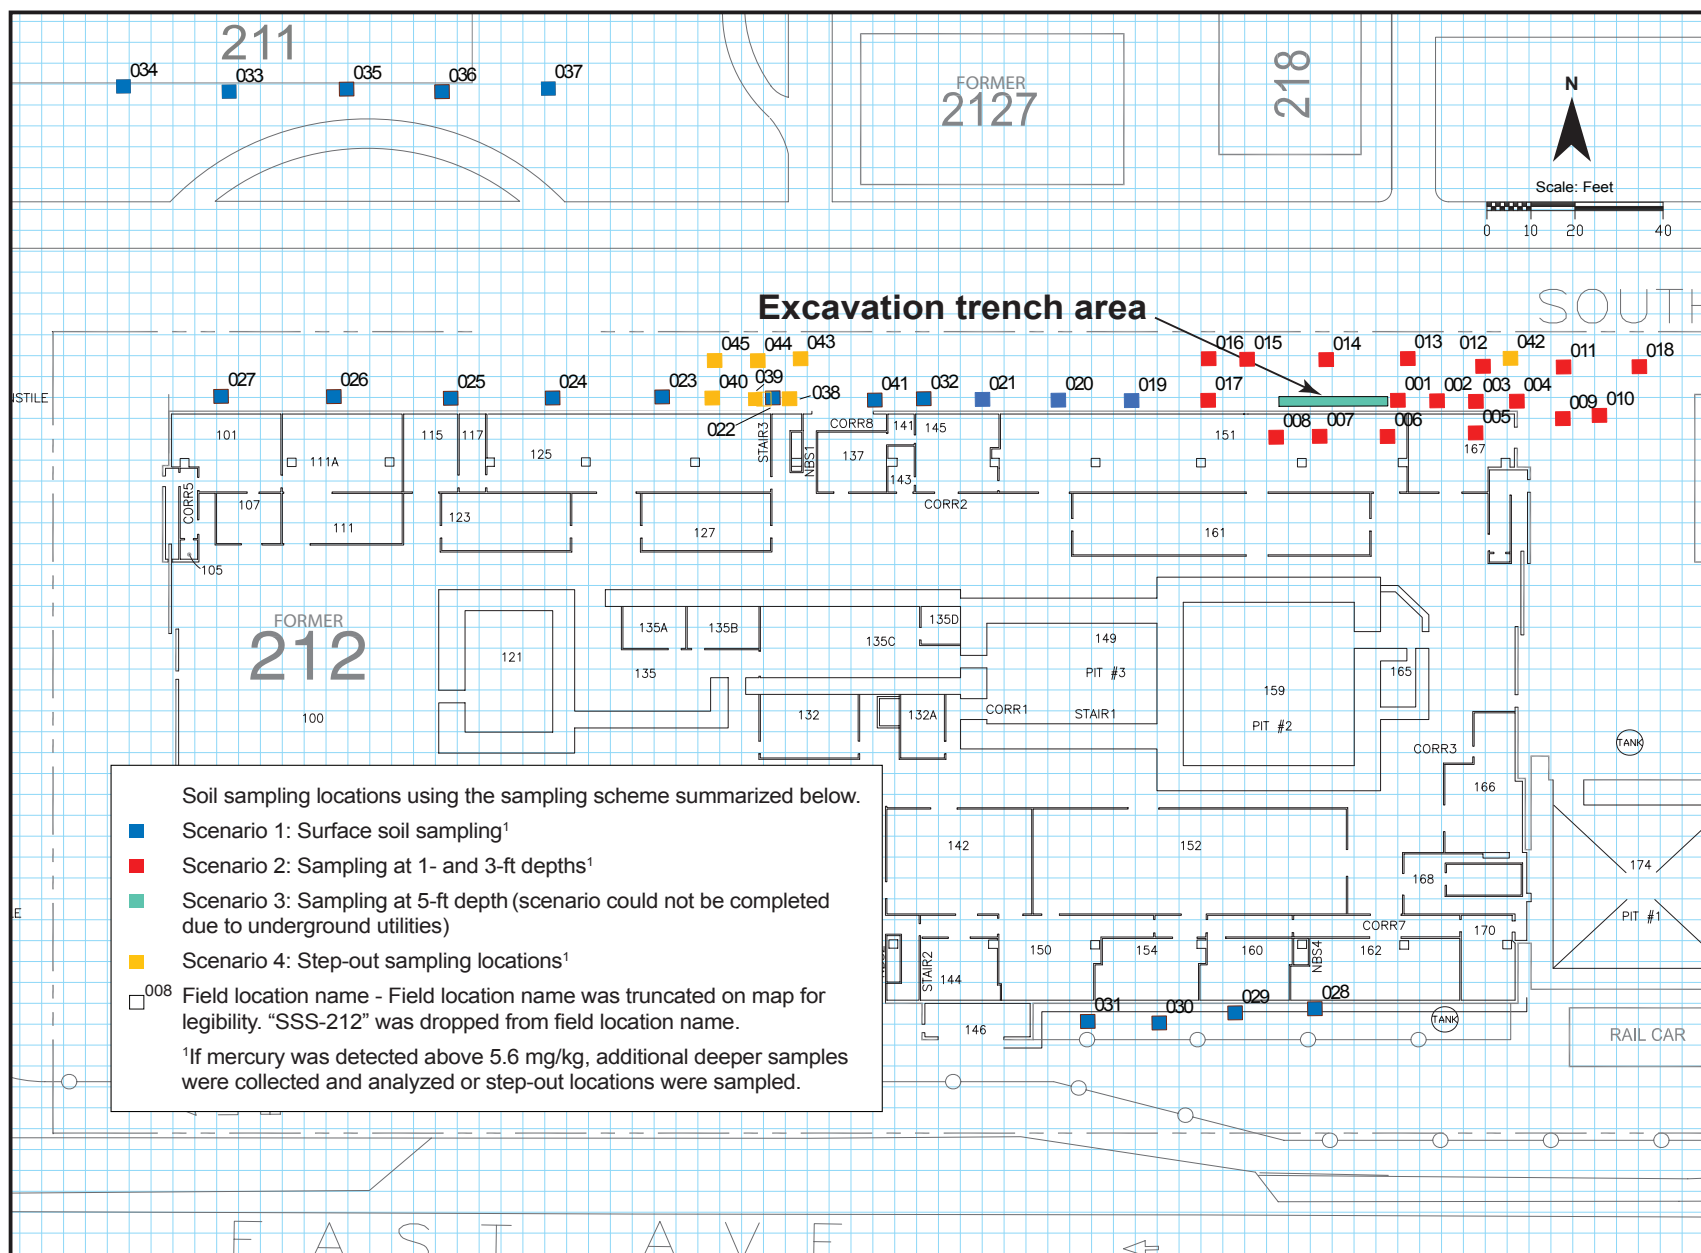
ERD-LSR-11-0026

Figure 2g. Soil sample locations, as part of the mercury investigation in the Building 212 Area, LLNL.

Soil samples were collected at 45 locations, including seven step-out locations (Figure 2g). No free mercury was encountered and the extent of mercury in soil in the Building 212 area was found to be limited to two areas. The first area, measuring approximately 45 ft x 10 ft, included the eastern 15 ft of the trench excavated in 2008 where free mercury was observed on the northeast side of the building slab. Mercury was detected at 14 and 26 mg/kg, but additional samples to the east confirmed that mercury above the SL does not extend further east than the corner of the building, and no farther than 10 ft north from the edge of the building foundation. The second mercury-impacted area, which is approximately 35 ft x 10 ft, is located west of the former trench and near a former staircase that led into Building 212. In this area, mercury was detected at 8.9 and 5.69 mg/kg at the surface and 1.5 ft, respectively.

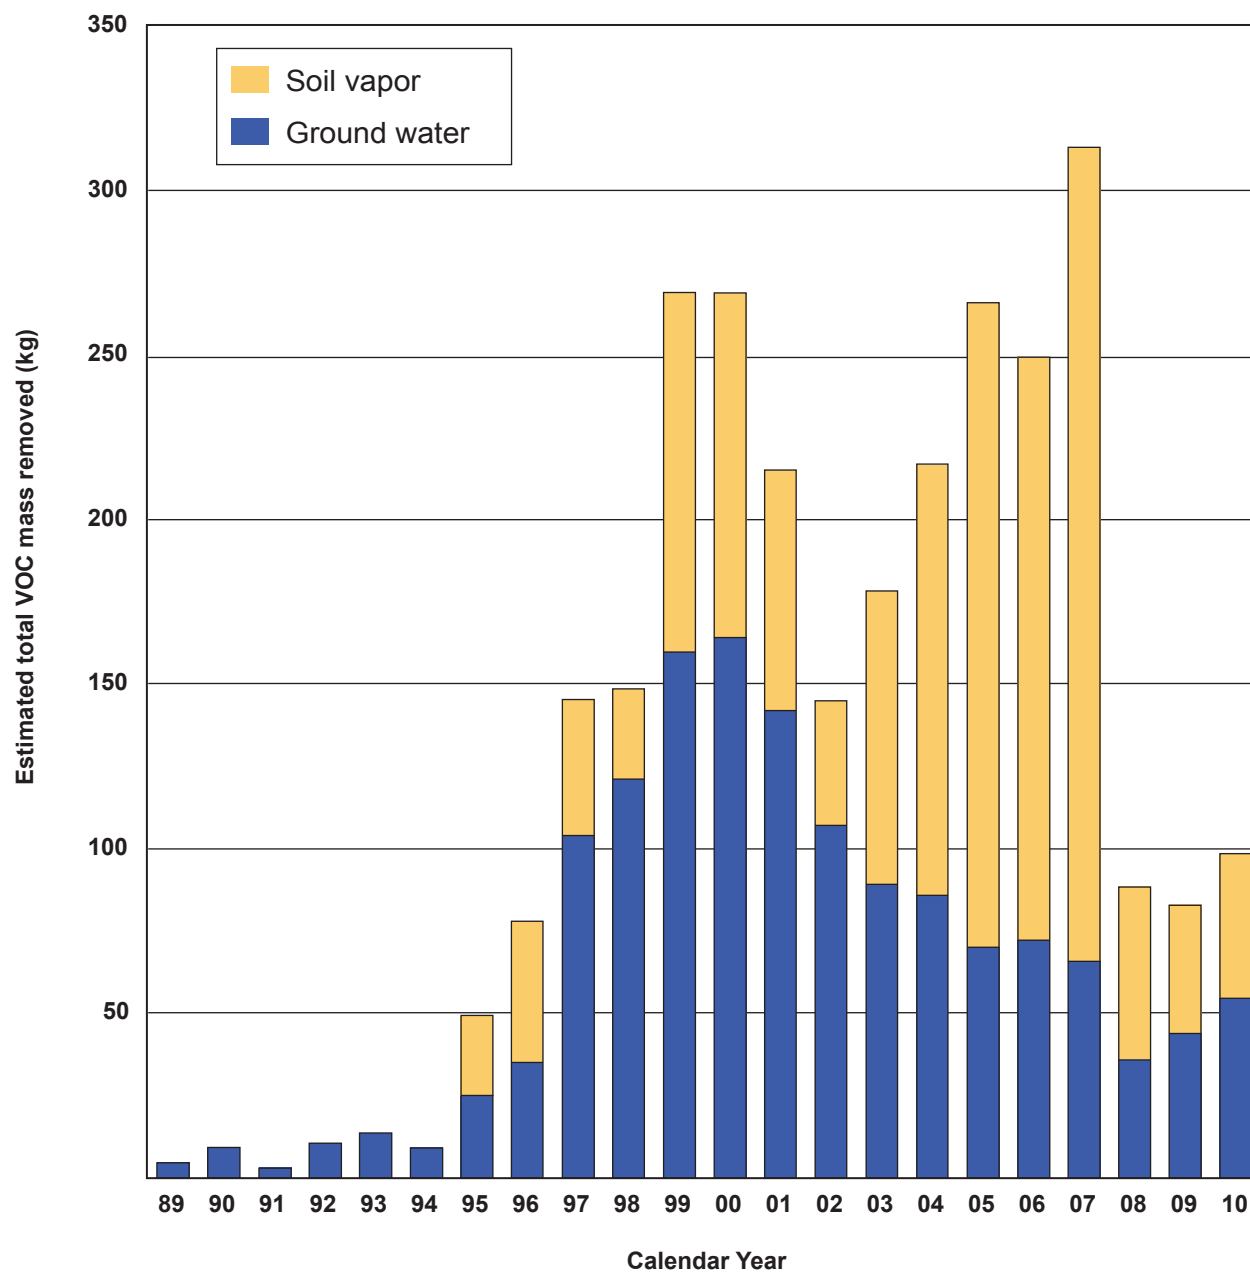
ERD_LSR_11_0017

Figure 3. Estimated total VOC mass removed from the Livermore Site subsurface since 1989.

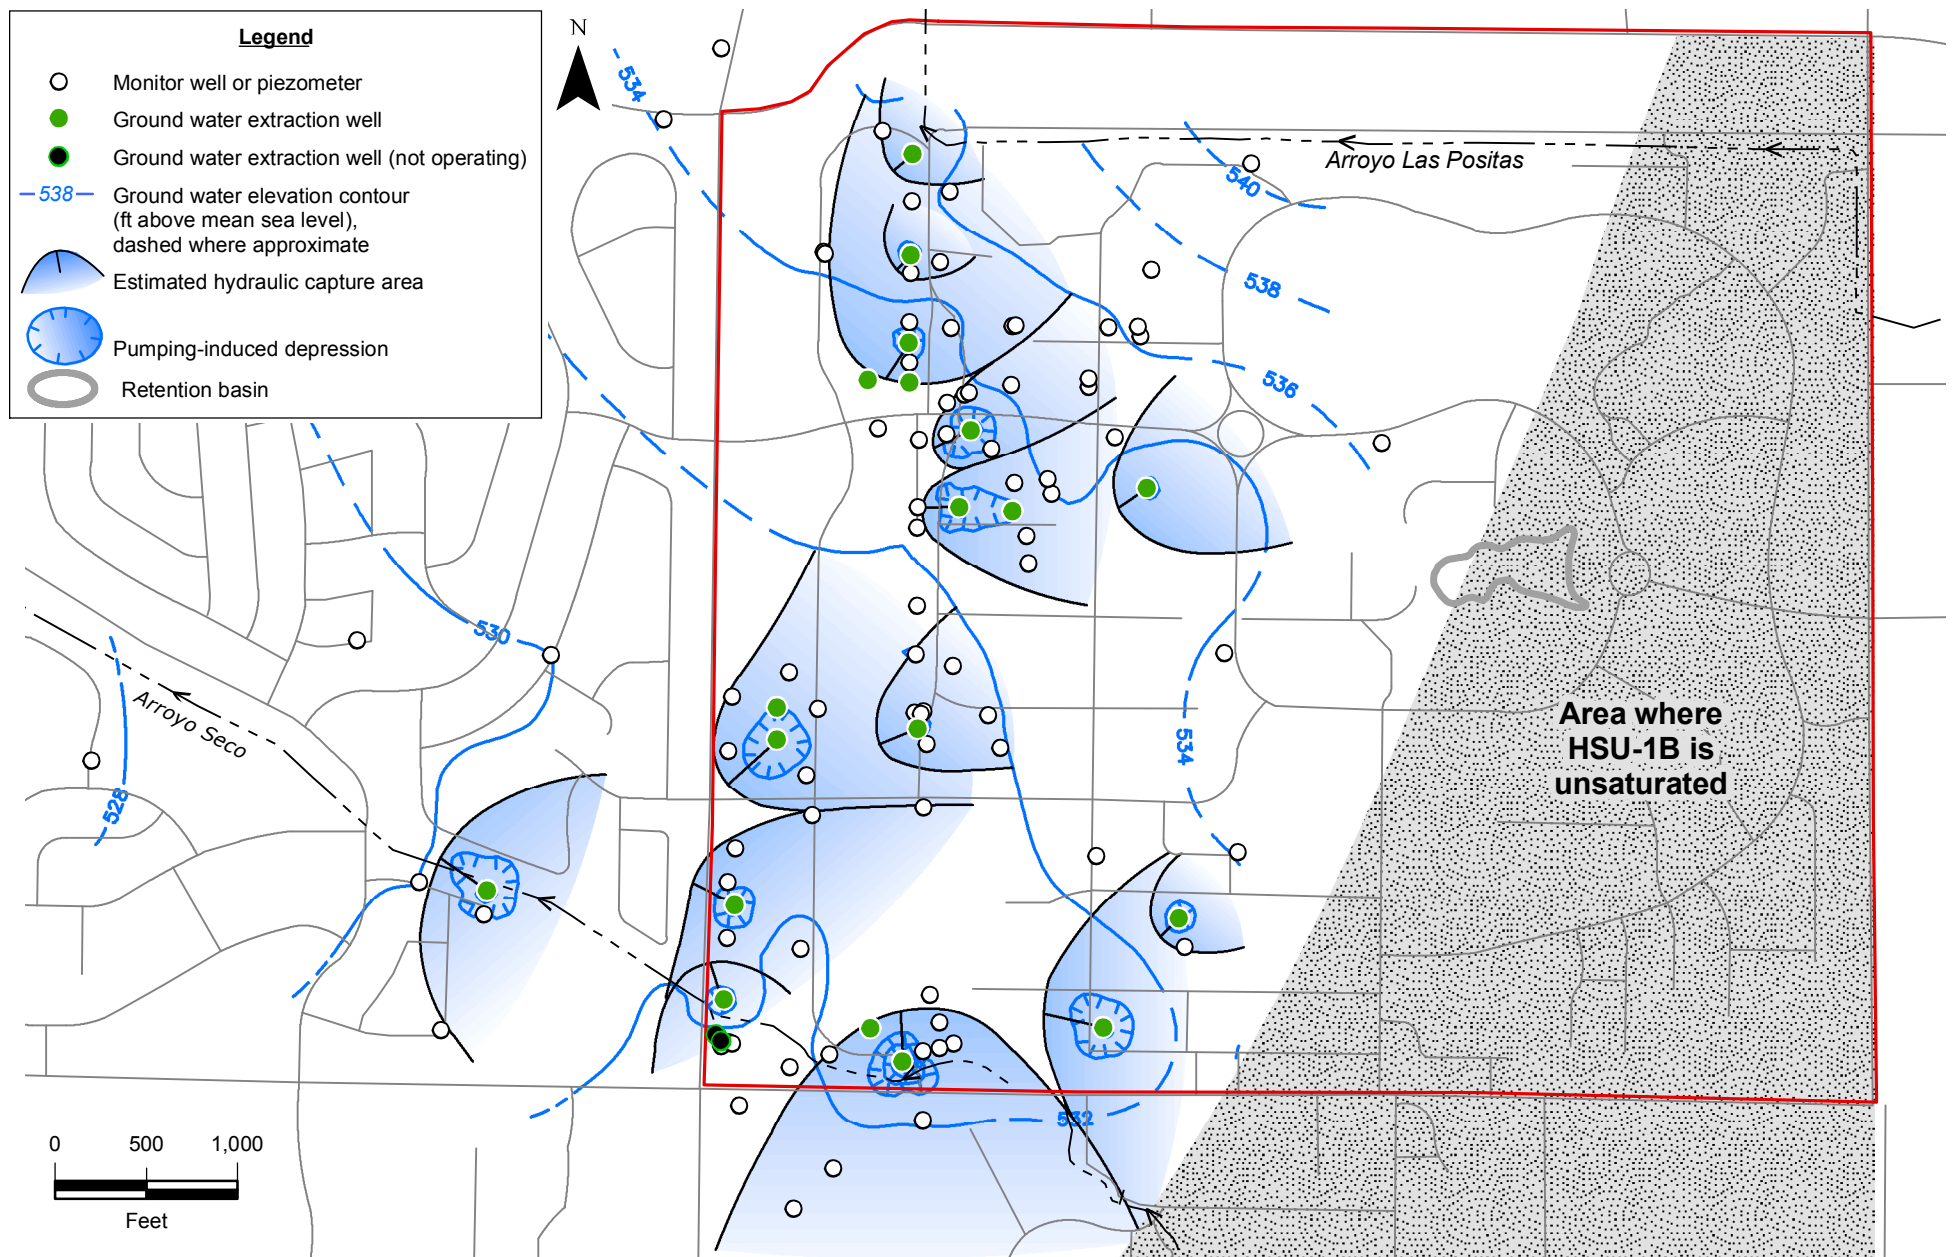
Figure 4. Ground water elevation contour map based on 129 wells completed within HSU 1B showing estimated hydraulic capture areas, LLNL and vicinity, July 2010.

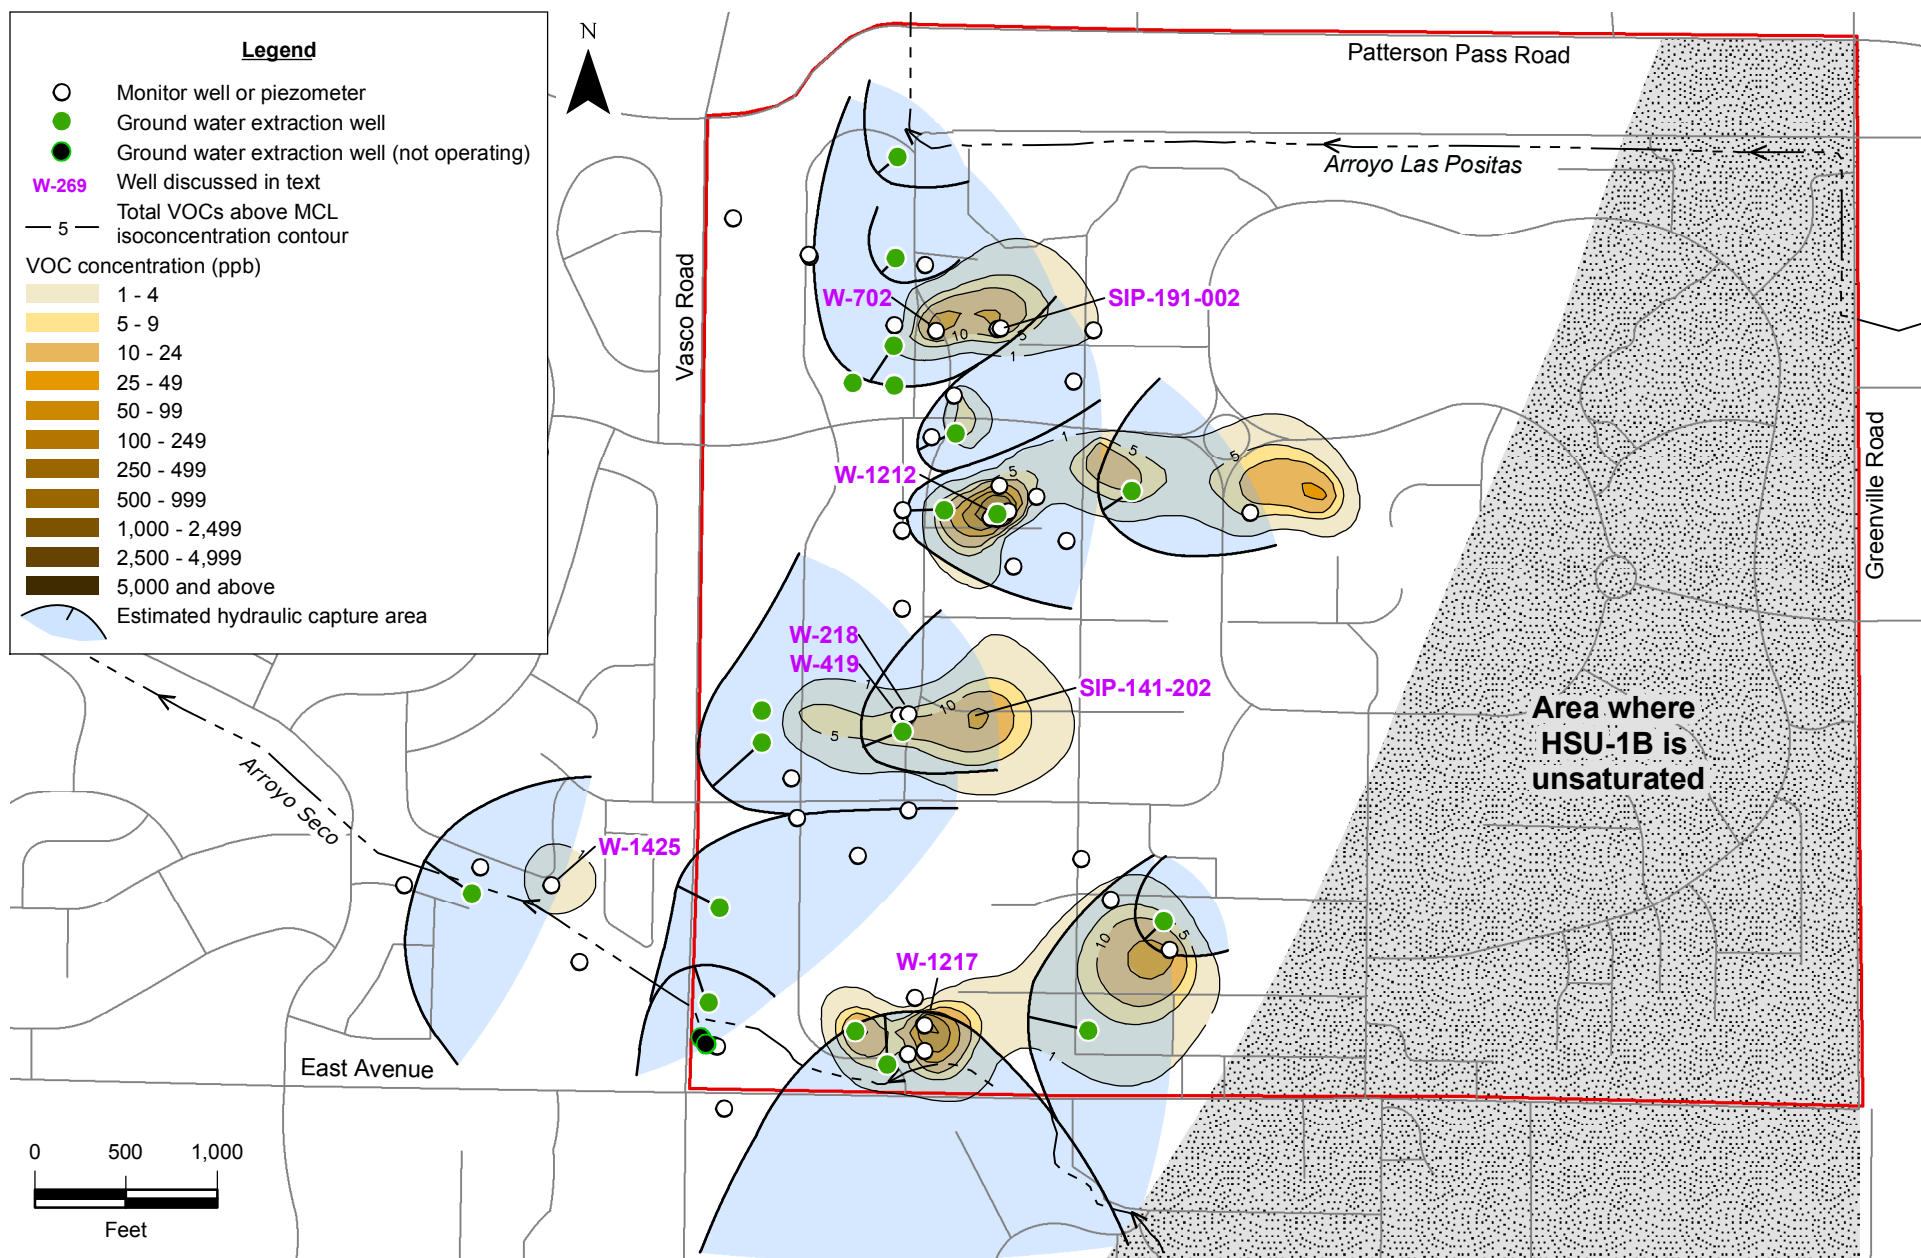
Figure 5. Isoconcentration contour map of total VOCs above MCLs from 129 wells completed within HSU 1B, third quarter 2010 (or the next most recent data), and supplemented with soil chemistry data from 40 borehole locations.
